July 2013

Field Service Bulletin 26

SBE 49 FastCAT CTD

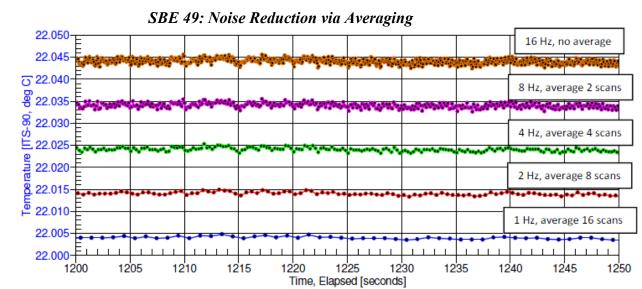
A field report and subsequent testing at Sea-Bird revealed a noise signal in the temperature channel of approximately 2.5 mK peak-to-peak, at a frequency of 3 to 4 Hz. Parameters that are calculated using CTD temperature are affected similarly in magnitude and frequency (for example, salinity noise of approximately 0.003 psu peak-to-peak). The character of the noise is such that averaging of the SBE 49 data substantially reduces the effect of the noise. The SBE 49 samples at 16 Hz, and can be set up to average up to 255 samples (transmitting only the averaged data). The table and figure illustrate noise reduction through averaging data scans in the SBE 49.

For customers who are averaging 8 or more scans per sample in the SBE 49 and transmitting the averaged data, the noise is small compared to the instrument accuracy, and will have negligible impact on the output.

An electro-magnetic (EM) modification to the SBE 49 substantially eliminates the noise. Sea-Bird has implemented this modification in all SBE 49s built after May 2013 (approximately serial numbers 0321 and later).

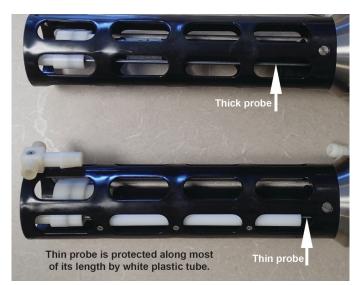
Temperature Sensor Modification for Serial Numbers 0276 - 0320, corresponding to SBE 49s shipped August 2012 - May 2013 (serial numbers approximate; see photo to compare to your SBE 49)

In August 2012 Sea-Bird began using a thinner temperature probe than the previous design (see photo). The thin probe uses the same thermistor resistor component as the thick probe, but the sheath design was modified due to a material change. The change was intended as temporary, until we could reproduce the original sheath with a new material. Although there have not been any reported failures, Sea-Bird returned to the original thick probe design in June 2013.

Sea-Bird returned to the thick temperature probe design in all SBE 49s built after May 2013.

Temperature Probe Design	Problem with Data? (data does not meet customer needs because of noise)	Customer returning SBE 49 for Service that requires Disassembly? (for example, repair or replacement of circuit boards)	Sea-Bird Response
Thick -	no	no	Perform requested service (standard charge)
	no	yes	Perform EM modification (no charge) in
			addition to requested service (standard charge)
	yes	no	Perform EM modification (no charge)
	yes	yes	Perform EM modification (no charge) in
			addition to requested service (standard charge)
Thin	no or yes	no or yes	Perform EM modification and change to thick
			temperature probe (no charge), in addition to
			requested service (standard charge)
