APPLICATION NOTE NO. 85

Handling of Ferrite Core on Instruments with Inductive Modem Telemetry

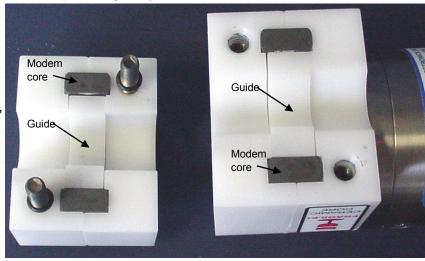
Mounting guide / Inductive Modem Coupler Detail

Guide is sized *slightly* bigger than specified cable diameter, to allow cable to pass through freely but limit vibration of instrument on cable

For proper communications, 2 halves of modem coupling toroid core must mate, with no gaps

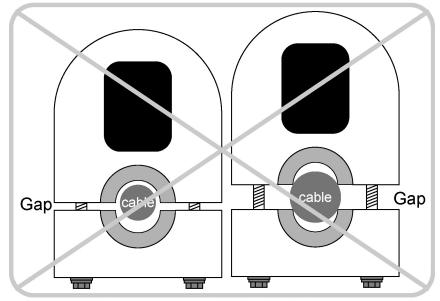
CORRECT -- Two modem halves mating closely (< 0.1 mm gap). Note that guide does not clamp cable.
