This application note is intended to assist you in maintaining your pump:

- SBE **5T** Titanium Submersible Pump – titanium housing (depth to 10,500 meters).
- SBE **5P** Plastic Submersible Pump – plastic housing (depth to 600 meters).
- SBE **5M** Miniature Submersible Pump – available in titanium housing (depth to 10,500 meters) or plastic housing (depth to 600 meters).

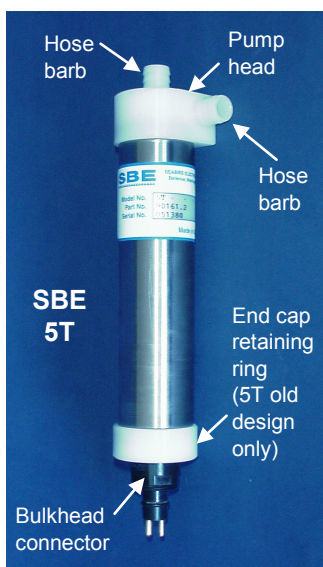
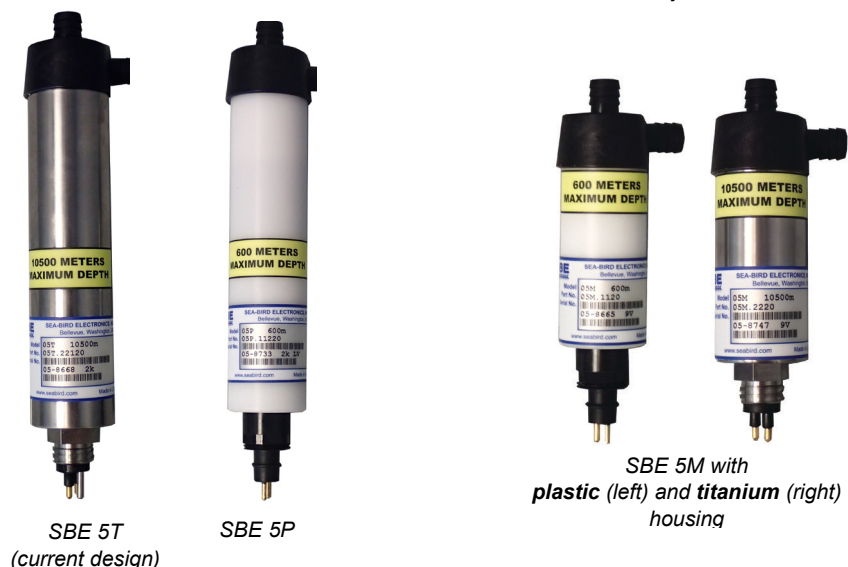
Note: **In 2011, Sea-Bird changed the SBE 5T mechanical design**; the current design is easily differentiated from the old design because the current design does not have a retaining ring (see photos below). The old SBE 5T is opened from the end with the retaining ring and bulkhead connector; the current SBE 5T is opened from the end with the pump head. Instructions for disassembly/reassembly of the current SBE 5T pump are identical to those for the SBE 5P pump.

Note: White pump head was replaced with black pump head for SBE 5M, 5P, and 5T in November 2015; dimensions and functionality are identical.

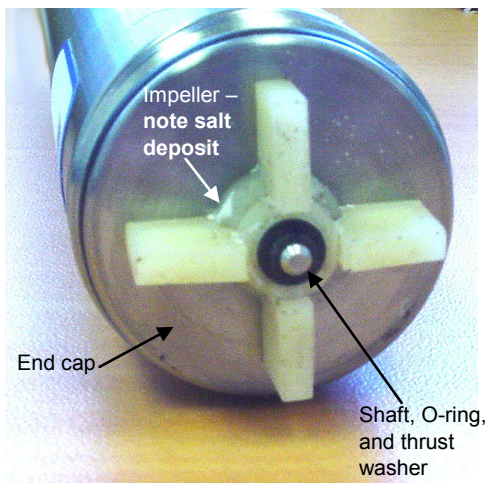
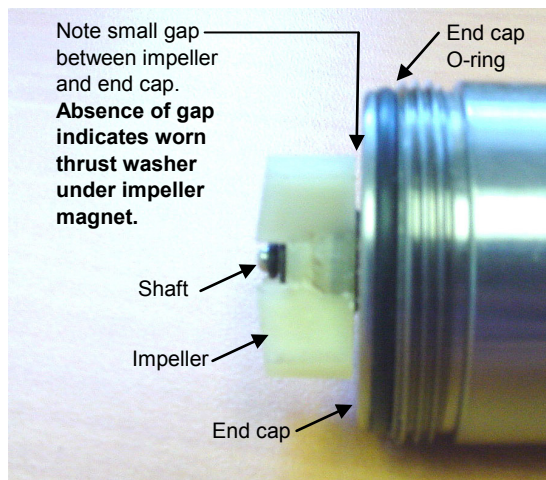
SBE 5T with Pump Head Removed

1. Unscrew the pump head from the housing.
2. Using clean, fresh water, thoroughly rinse the pump head and impeller.
3. Inspect the impeller for salt deposits. Clean any deposits with clean, fresh water and a toothbrush. Verify that the impeller can turn freely.
4. Inspect the shaft, and the O-ring and thrust washer holding the impeller on the shaft. There is another thrust washer underneath the impeller magnet, inside the housing. If this thrust washer is in good condition, you should observe a small gap between the bottom of the impeller and the end cap. If there is no gap, the thrust washer is worn and needs to be replaced (see *Yearly Maintenance for SBE 5T (old design)* for replacement procedure).

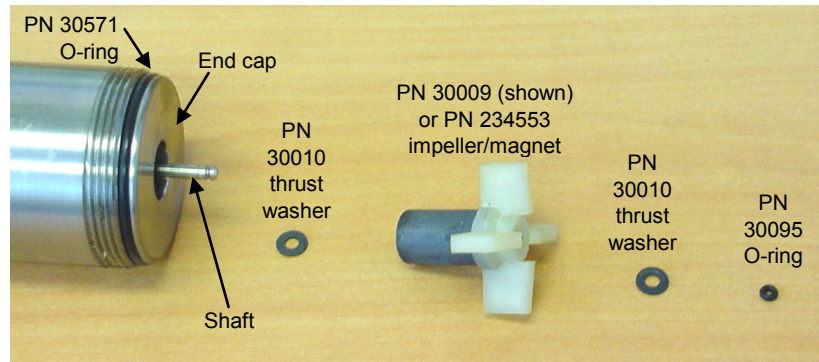
SBE 5T with Pump Head and Impeller Removed

- A. Remove the O-ring from the shaft. A pair of tweezers works well for this.
- B. Pull the impeller and attached magnet off the shaft. The thrust washer above the impeller will come off at the same time. Inspect the impeller for salt build-up, and clean if necessary. Inspect the magnet for wear. Particularly in sandy coastal environments, the magnet may be worn down from abrasion. If necessary, replace the impeller / magnet assembly (PN 30009 or 234553).

Note: PN 30009 (with white impeller, as shown in photo) was replaced by PN 234553 (with black impeller) in 2012. These parts are interchangeable.

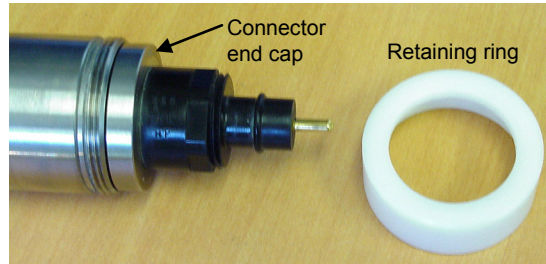
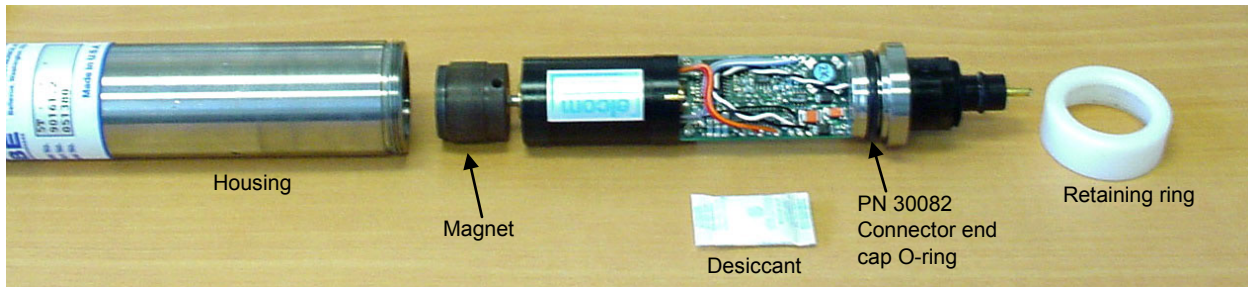
1. Unscrew the connector end cap retaining ring. Install a 2-pin dummy plug with locking sleeve over the bulkhead connector to provide a good grip and protect the connector pins. Rotate the end cap back and forth while carefully pulling the end cap away from the housing. Pull out the end cap and attached electronics from the housing.

2. Verify that the magnet can spin freely and is not broken or damaged.
3. Look for other signs of damage on the electronics.
4. Inspect the connector end cap O-ring and the mating surface in the housing for dirt, nicks, and cuts. Clean as necessary. If the O-ring or mating surface is damaged, return the pump to Sea-Bird for repairs.

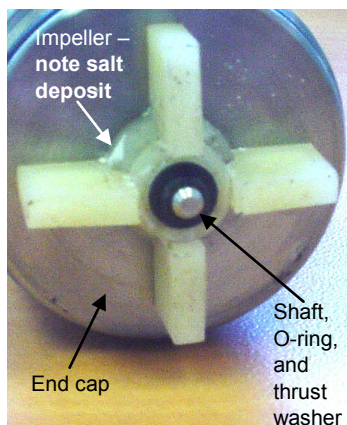
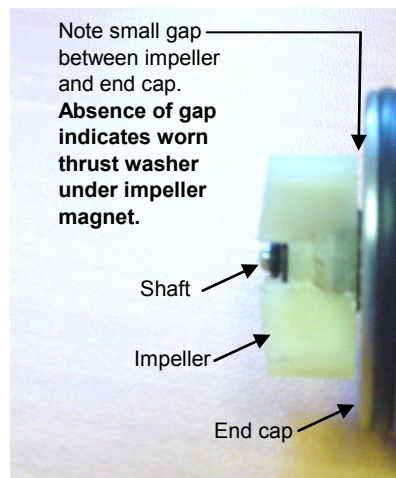
SBE 5M, 5P, or 5T with Pump Head Removed

4. Inspect the impeller for salt deposits. Clean any deposits with clean, fresh water and a toothbrush. Verify that the impeller can turn freely.
5. Inspect the shaft, and the O-ring and thrust washer holding the impeller on the shaft. There is another thrust washer underneath the impeller magnet, inside the housing. If this thrust washer is in good condition, you should observe a small gap between the bottom of the impeller and the end cap. If there is no gap, the thrust washer is worn and needs to be replaced (see *Yearly Maintenance for SBE 5M, 5P, or 5T (current design, no retaining ring)* for replacement procedure).

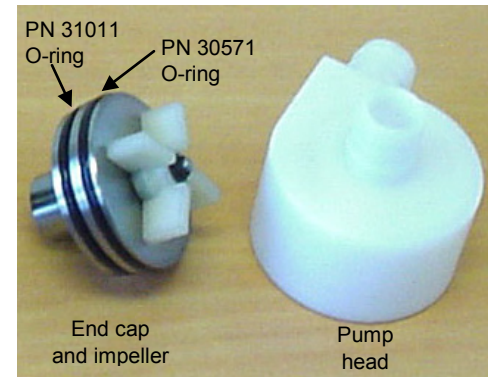
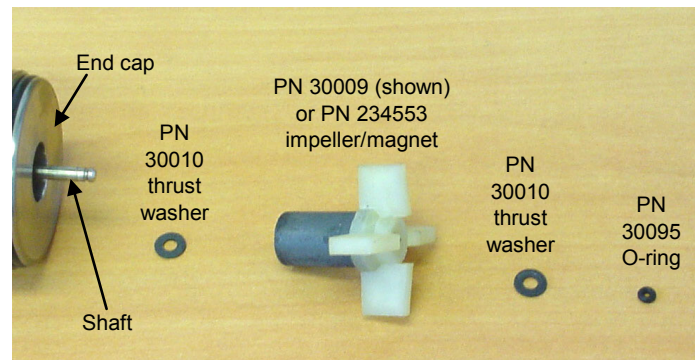
SBE 5M, 5P, or 5T with Pump Head and Impeller Removed

- A. Remove the O-ring from the shaft. A pair of tweezers works well for this.
- B. Pull the impeller and attached magnet off the shaft. The thrust washer above the impeller will come off at the same time. Inspect the impeller for salt build-up, and clean if necessary. Inspect the magnet for wear. Particularly in sandy coastal environments, the magnet may be worn down from abrasion. If necessary, replace the impeller / magnet assembly (PN 30009 or 234553).

Note: PN 30009 (with white impeller, as shown in photo) was replaced by PN 234553 (with black impeller) in 2012. These parts are interchangeable.

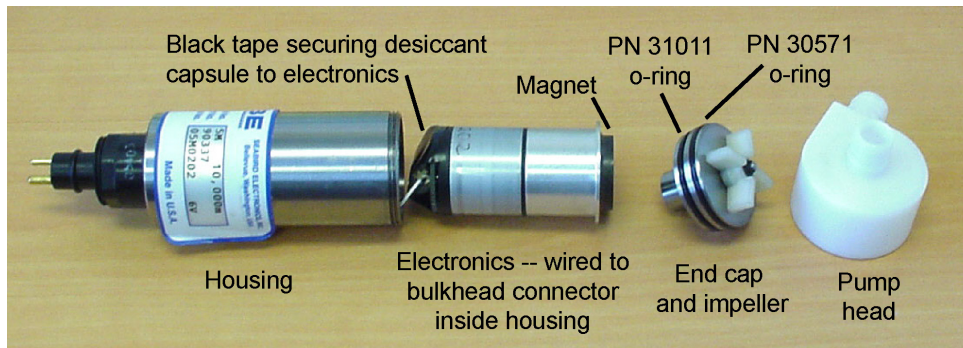
SBE 5M with Electronics Removed (titanium version shown; plastic version similar)

1. Unscrew the pump head from the housing.
2. Pull out the end cap from the housing.
3. Pull out the electronics from the housing. Note that the electronics are wired to the bulkhead connector inside the housing.

- B. **SBE 5M** – Gently place a **new desiccant capsule** (PN 31044 – 0.4 gram) on the electronics, and replace the black tape to secure it in place.
SBE 5P or 5T - Gently place a **new desiccant bag** (PN 30558 – 1 gram) on the electronics.
 (see *Application Note 71* for desiccant use and regeneration).
