Module 15

Troubleshooting

Overview

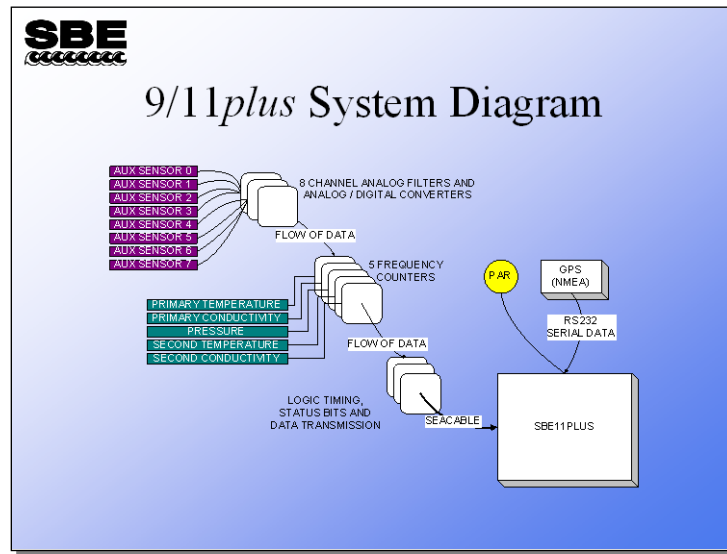
Troubleshooting: 911plus

The 911plus is a highly modular system. You can exploit this characteristic of the instrument in troubleshooting. You can swap sensors, swap cables, and if necessary, swap printed circuit boards to see if trouble follows any one of these components.

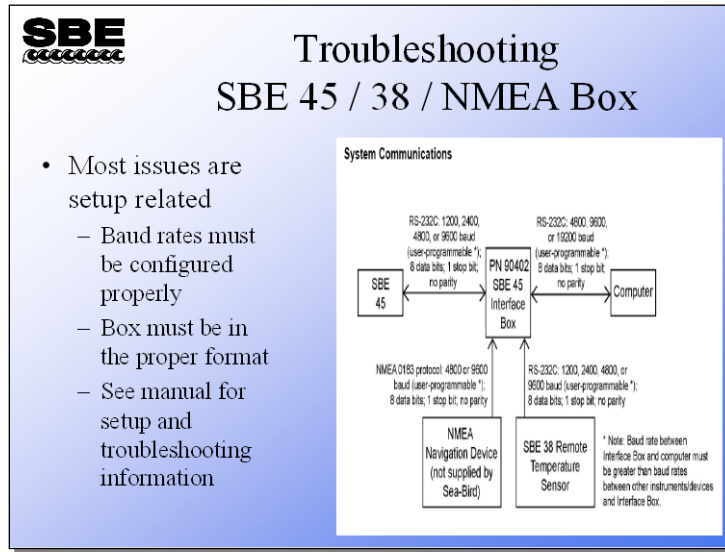
Troubleshooting: Opto / NMEA Boxes

Sea-Bird manufactures an interface box specifically for the use with SBE 45 MicroTSG thermosalinograph, called the *SBE 45 Power, Navigation, and Remote Temperature Interface Box*. Note that the **baud rate between the Interface Box and the computer must be greater than the baud rates between the other instruments / devices and the Interface Box**.

Sea-Bird has manufactured a variety of different models of Opto / NMEA Boxes over the years. The current production model is called the *Seacat/Sealogger RS-232 and Navigation Interface Box*, and is available in AC-powered (PN 90488) and DC-powered (PN 90545) versions. This Box is supplied as a standard component with the SBE 21 Thermosalinograph, and can also be used with an SBE 16, *16plus*, 19, *19plus*, 25, or *25plus* CTD.
