Module 15

Troubleshooting

SBE
Troubleshooting

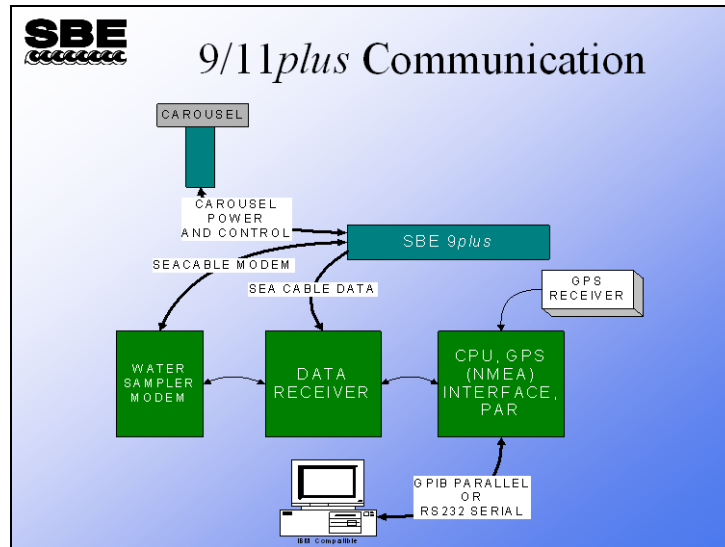
Troubleshooting: 911plus (continued)

Here is a signal flow diagram for the circuit boards in the 11plus, the 9plus, the Carousel, and your PC. Note that water sampler commands pass from your computer to the 11plus CPU board, to the receiver board, to the modem board, to the 9plus, and into the Carousel.

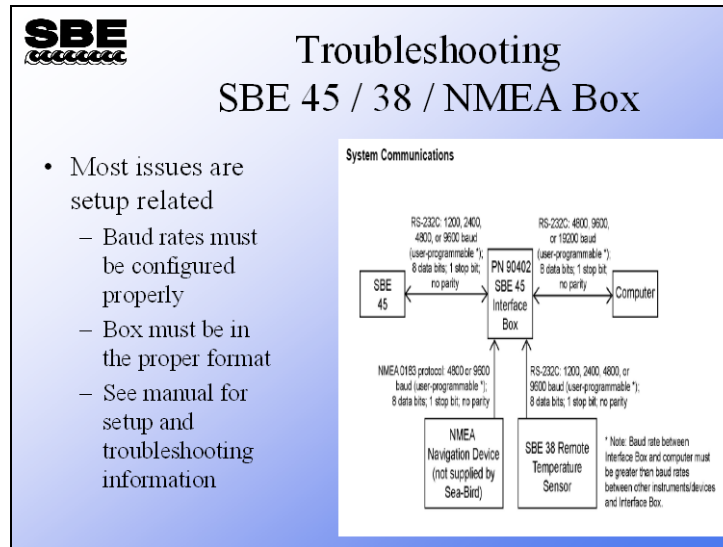
Troubleshooting: Opto / NMEA Boxes

Sea-Bird manufactures an interface box specifically for the use with SBE 45 MicroTSG thermosalinograph, called the *SBE 45 Power, Navigation, and Remote Temperature Interface Box*. Note that the **baud rate between the Interface Box and the computer must be greater than the baud rates between the other instruments / devices and the Interface Box**.

Sea-Bird has manufactured a variety of different models of Opto / NMEA Boxes over the years. The current production model is called the *Seacat/Sealogger RS-232 and Navigation Interface Box*, and is available in AC-powered (PN 90488) and DC-powered (PN 90545) versions. This Box is supplied as a standard component with the SBE 21 Thermosalinograph, and can also be used with an SBE 16, *16plus*, 19, *19plus*, or 25 CTD.

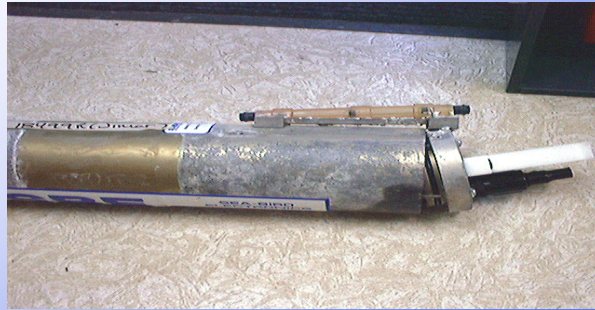
- What is wrong with this instrument?
